I-Spy Home Inspection

Home Inspection Report

123 Anystreet Drive

Inspected on Wed, Jan 1 2014 at 12:00 AM

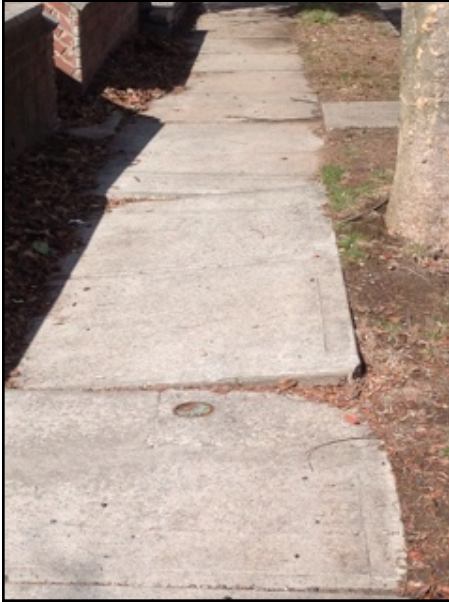
Figure 1-1

The sidewalk has heaved from the root growth of a nearby tree. This is a trip hazard and a safety issue.

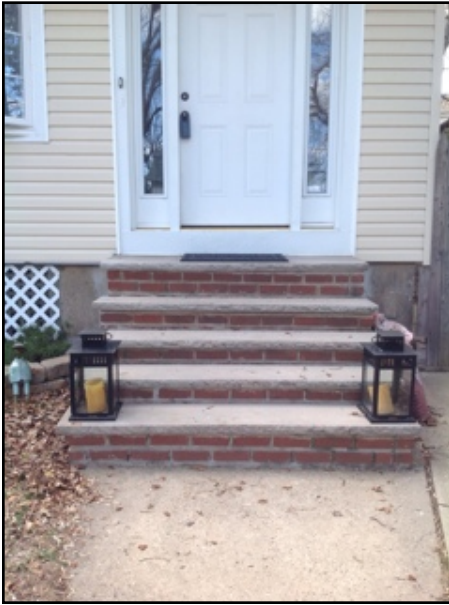
Figure 2-1

First, there are no railings on the upper stairs by the front door. This is a safety issue and may be required by the town for a CO.

Second, the steps are all different heights. This is a trip hazard as well and also may require correction for a CO from the town.

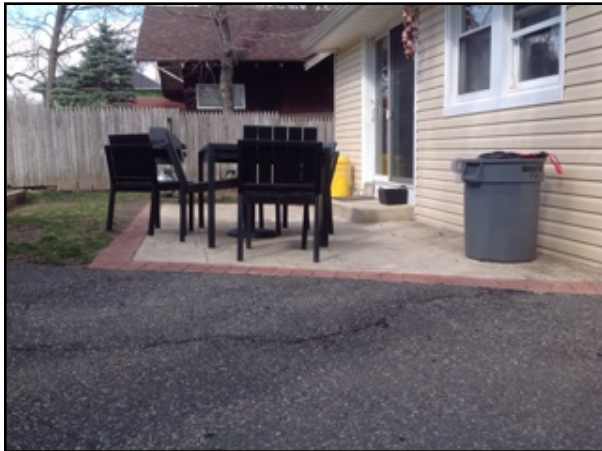
Figure 3-1

The rear patio is sloped slightly towards the home, but is sloped more to the north side of the house.

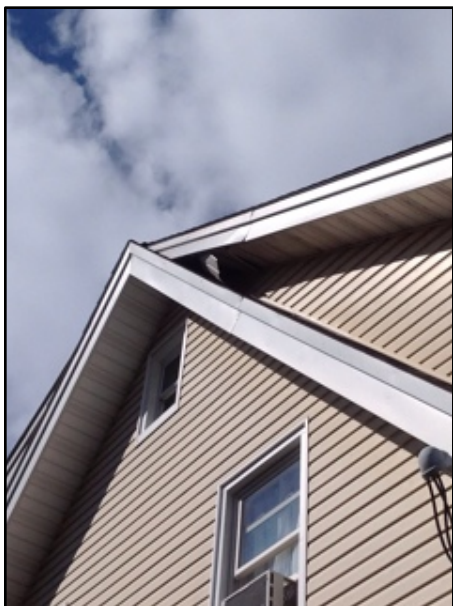
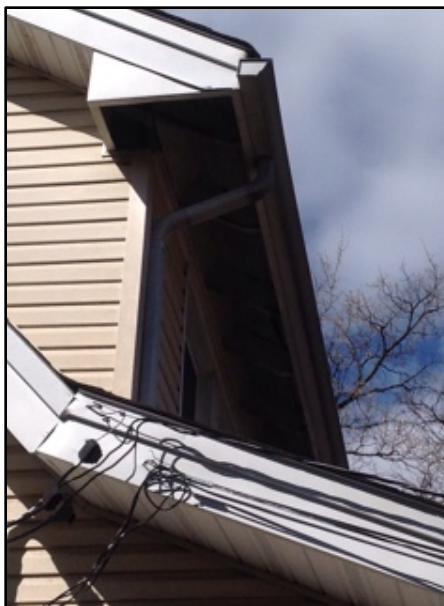
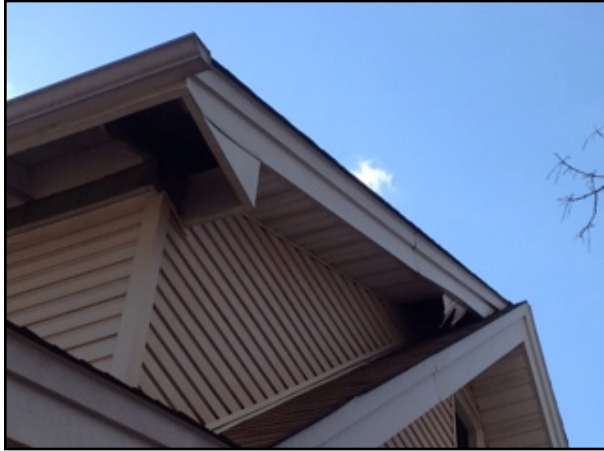
The soffit coverings are missing across the upper front of the house. The soffits in the upper gables are falling out on both sides of the house. A contractor or handyman should be consulted.

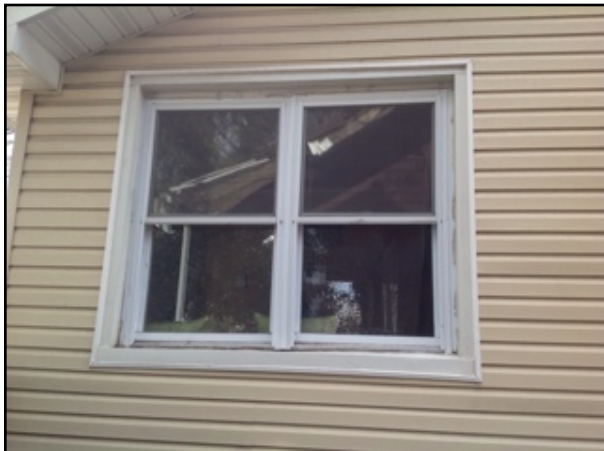
Figure 5-1

The exterior of several of the vinyl windows has caulking that is split allowing temperature transfer and water ingress. All caulking requires periodic maintenance.

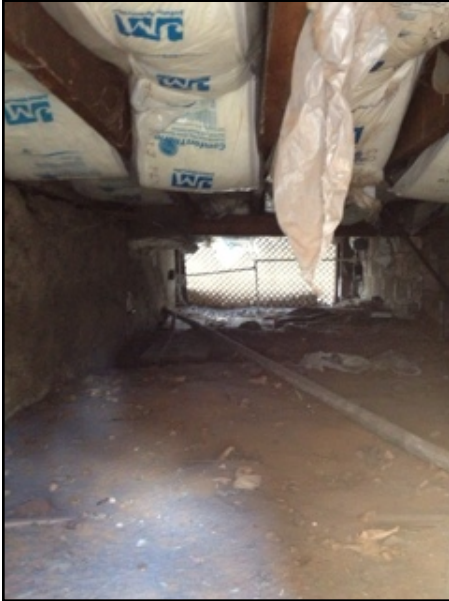
Figure 6-1

The front porch was enclosed to enlarge the living area of the home. That required insulation between the joists under the porch and several pieces of the insulation are falling out.

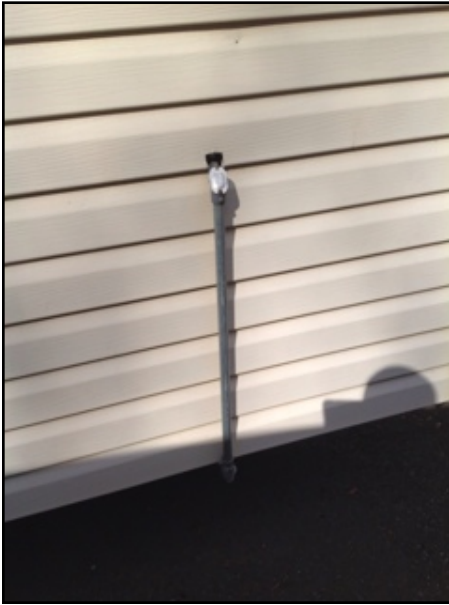
Figure 7-1

There is a large hole where an electrical conduit enters the structure. This should be sealed off to prevent water entry or insect nesting.

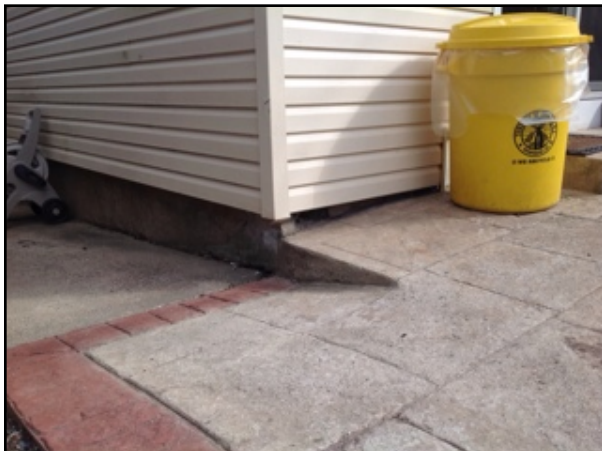
Figure 8-1

The crack between the foundation and the walkway on the north side of the house should be cleaned out and sealed with a flexible caulk to keep moisture from getting down to the foundation.

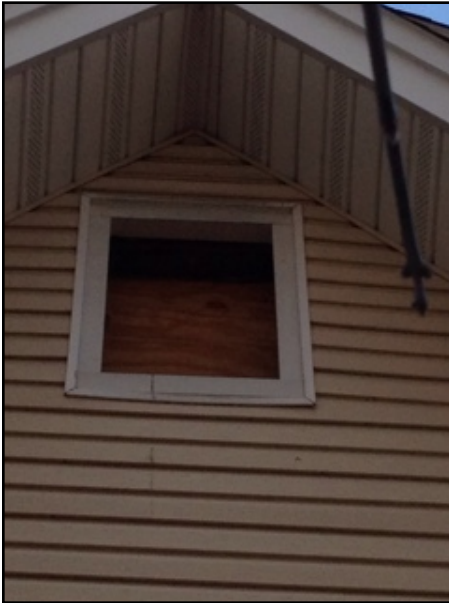
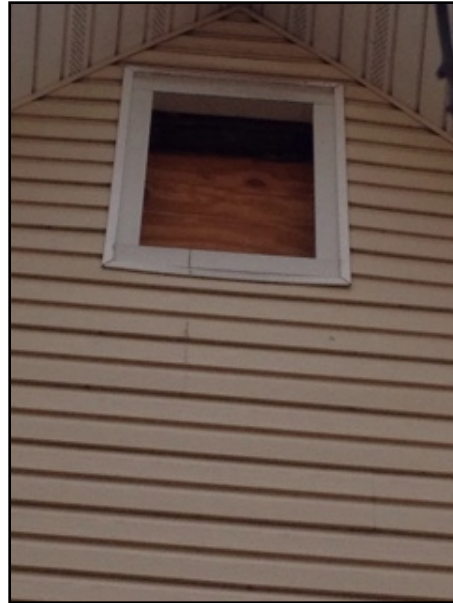
The north side of the home is missing a window at the attic level. It has been boarded up from the inside allowing possible water entry into the structure. Water was not visible from inside the attic but this should be sealed from the exterior.

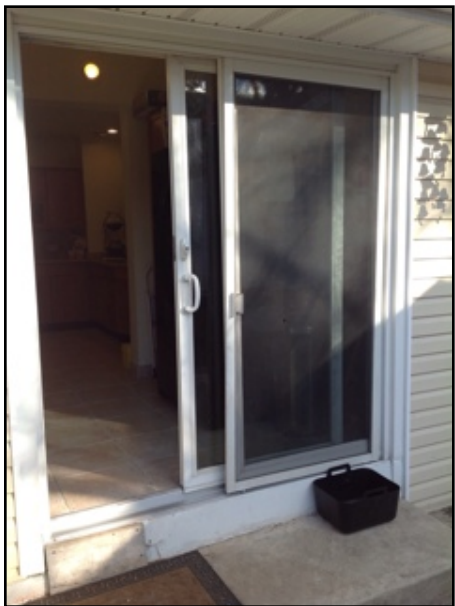
Figure 10-1

The screen on the rear sliding door has holes in it and is off the track because the rollers are bad.

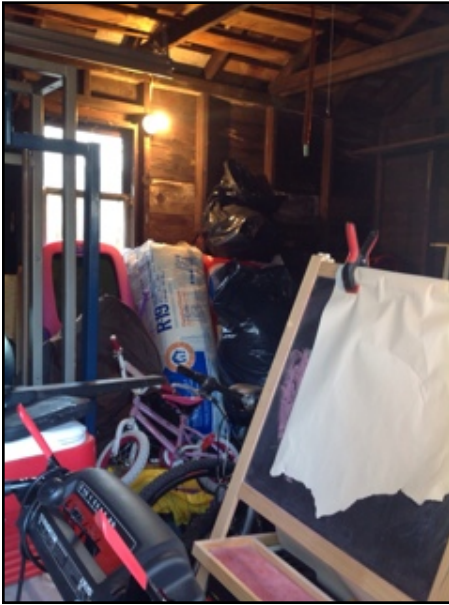
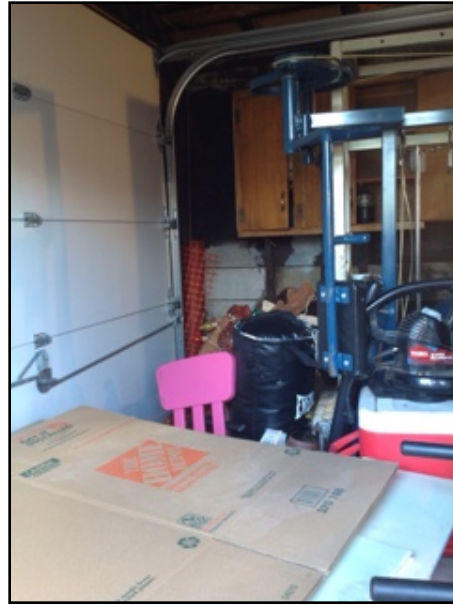
Comment 11:
The garage interior was inaccessible due to excessive storage. Items mentioned in this report were visible from the man door only.

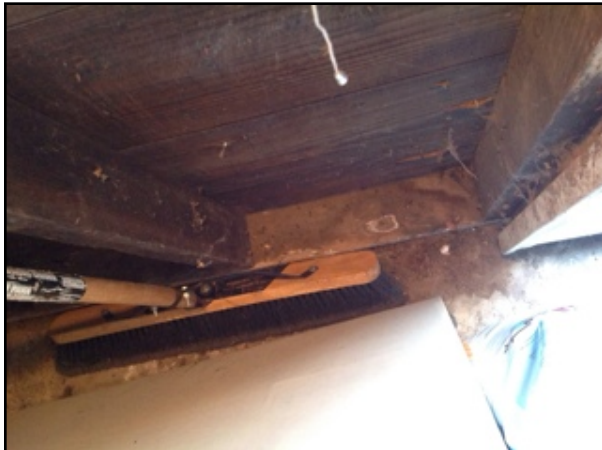
Figure 12-1

Comment 12:
Mouse droppings were noted in the garage.

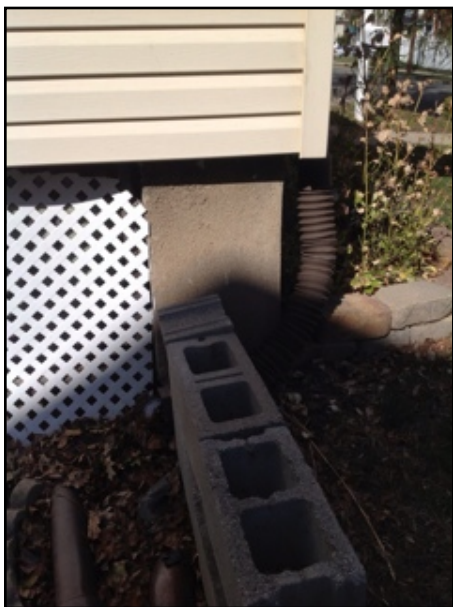
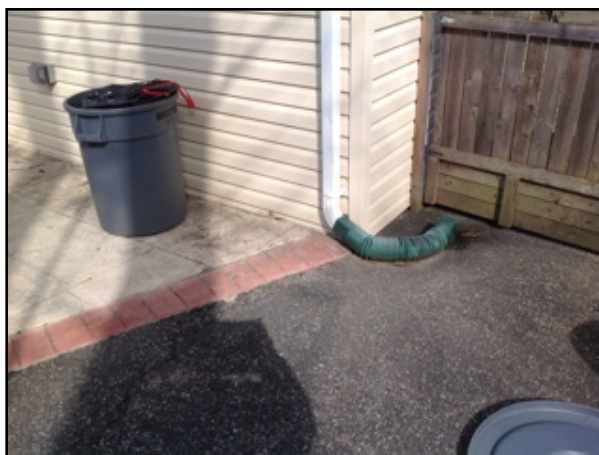
Comment 14:
Downspout drains should end at a minimum of 4 feet from the house.

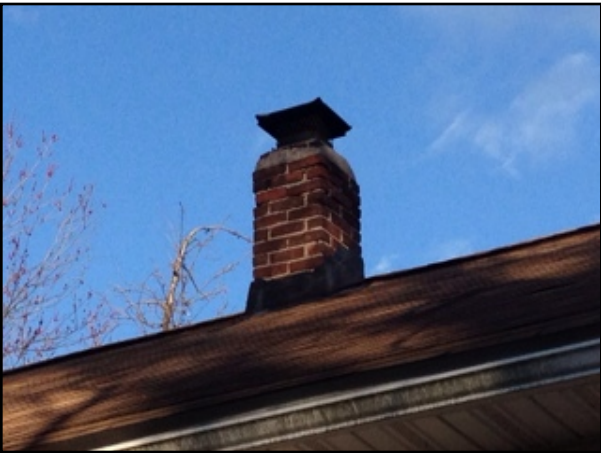
Figure 15-1

Comment 15:
The masonry on the chimney is cracking and coming apart. This is a safety hazard because pieces can drop down and hurt someone. A mason should be consulted.

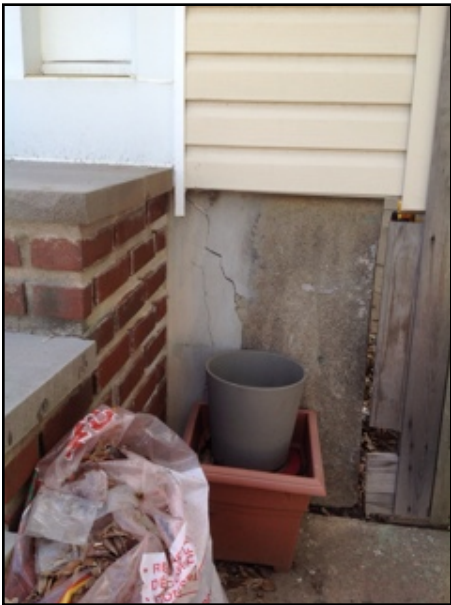
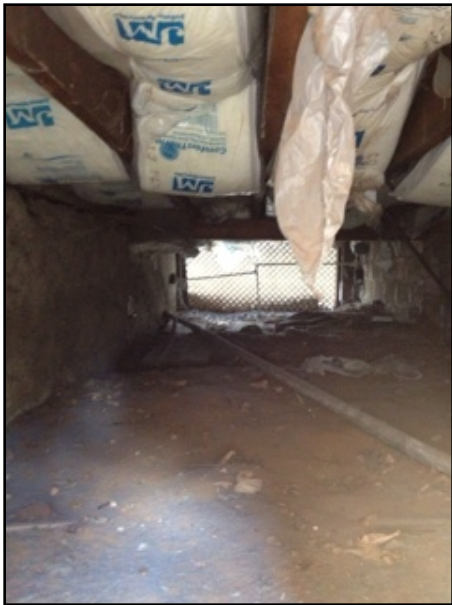
There are some cracks in the support for the enclosed front porch. Because it is part of the porch, it is not part of the foundation. A structural engineer should be consulted.

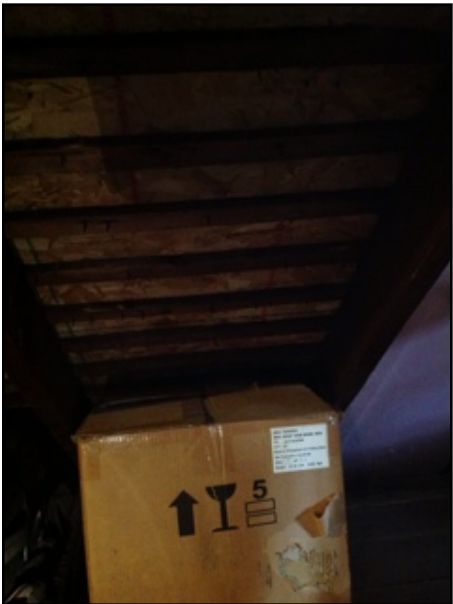
Figure 17-1

Comment 17:
There were several areas in the attic that were missing insulation. This leads to temperature transfer. Adding insulation will minimize the heat loss.

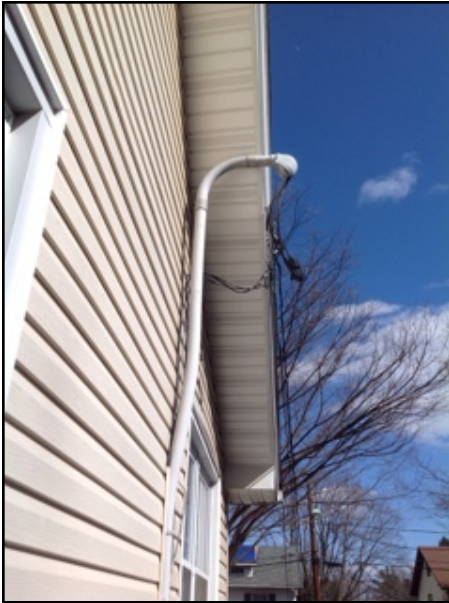
Figure 18-1

The service mast is not secured to the house at a minimum of every 2 feet. An electrician should be consulted.

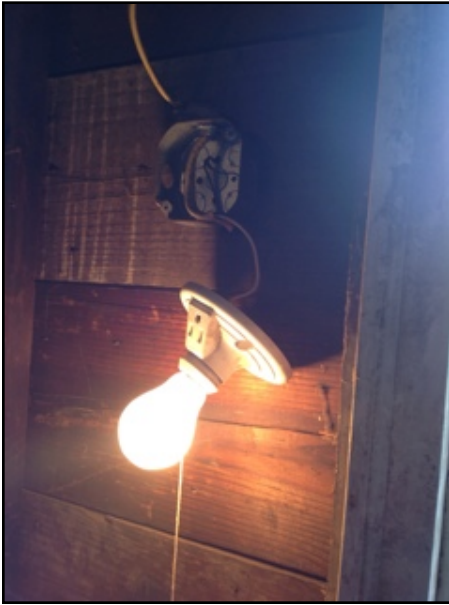
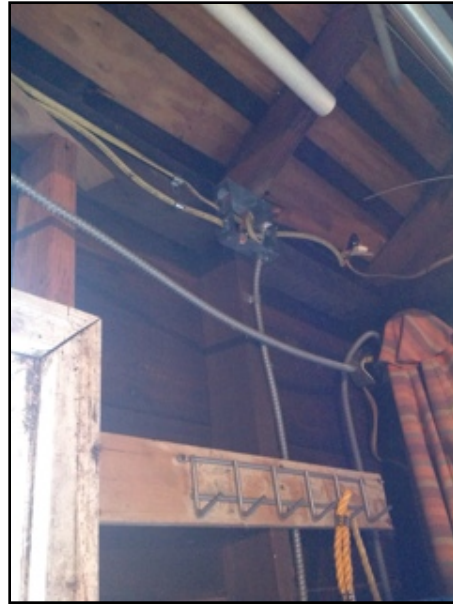
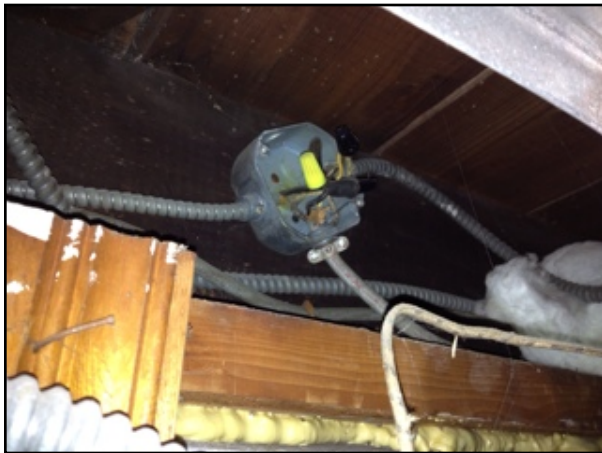
There are several open electrical boxes in the garage. This is a safety hazard. An electrician should be consulted.

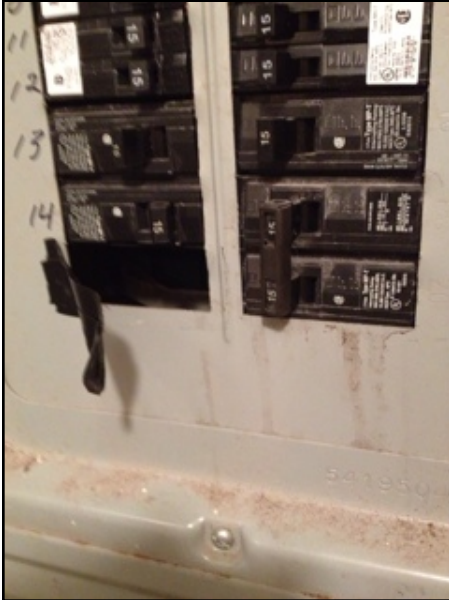
Figure 20-1

**Comment 20:**
There is an unprotected open slot in the main panel. This is a safety hazard.
Consult an electrician.

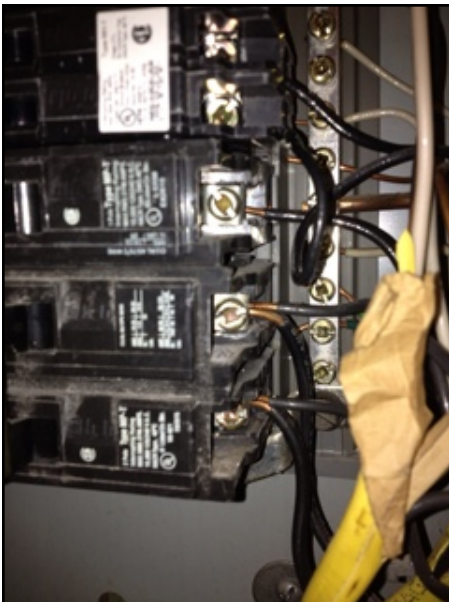
Figure 21-1

**Comment 21:**
There are two double taps in the panel. An electrician should be consulted.

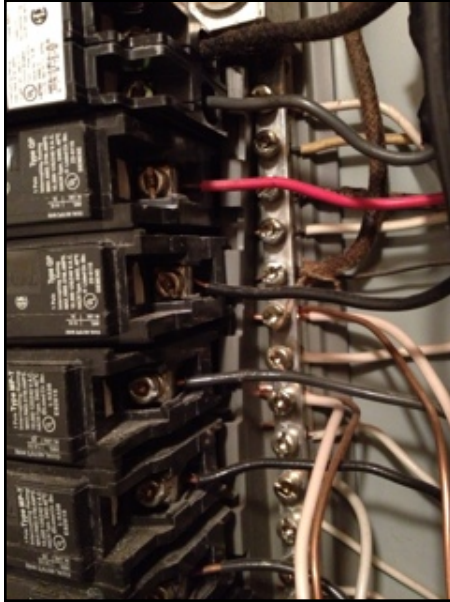
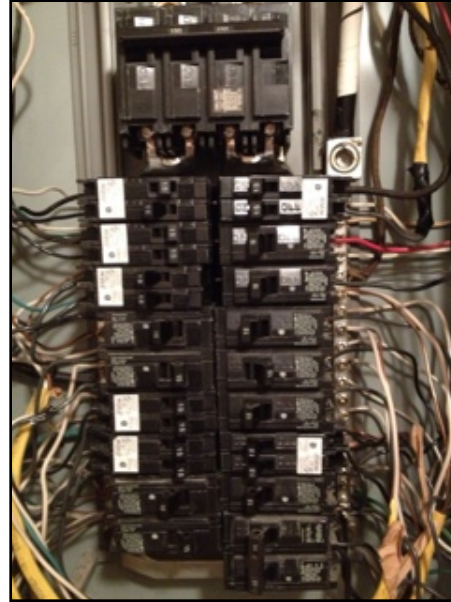
The bar that holds the breakers in on the right side is broken. An electrician should be consulted for repair.

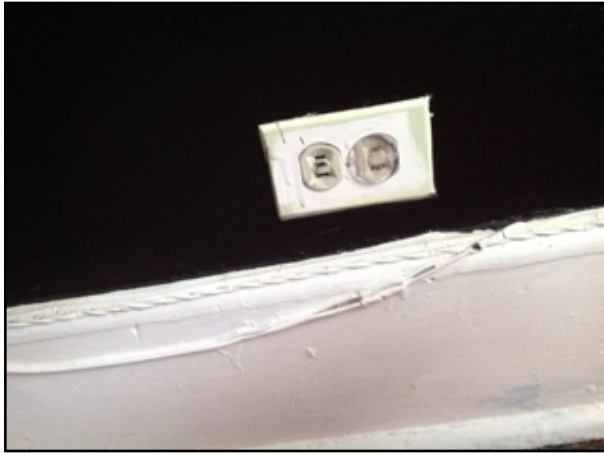
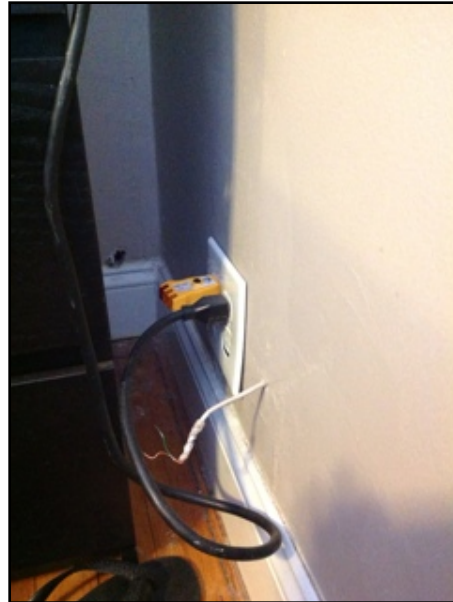
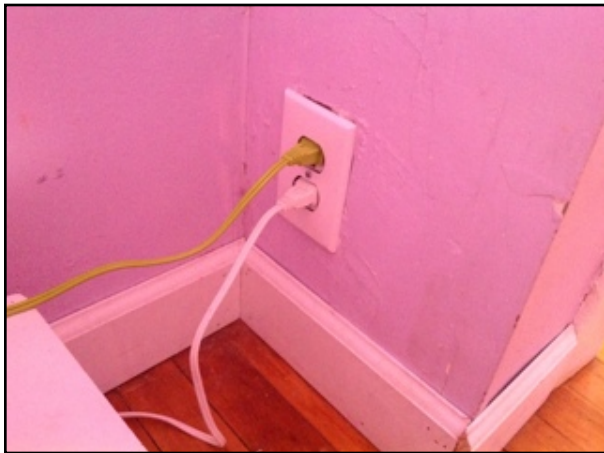
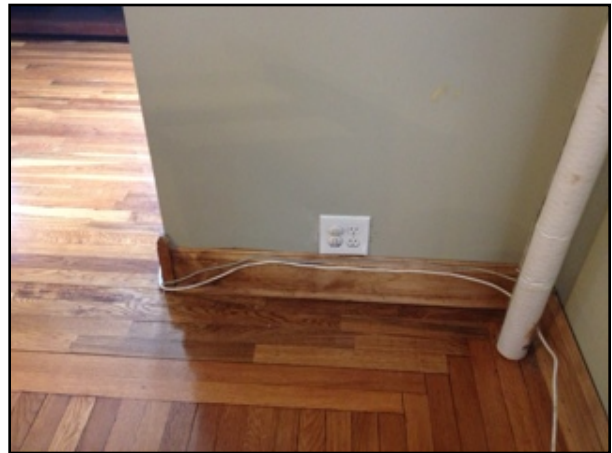
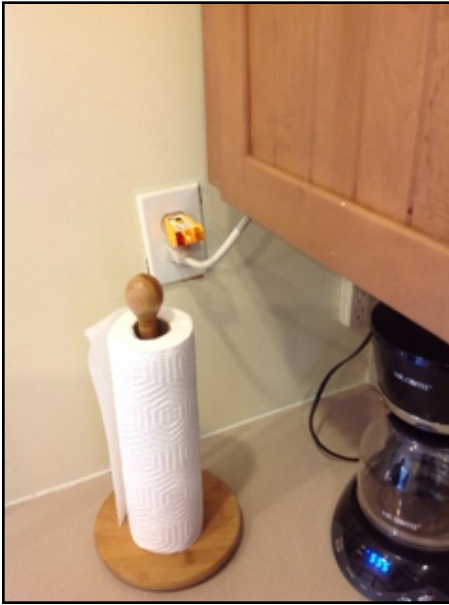
The small front bedroom has a 2 prong outlet. The master bedroom has an outlet with no power at all. The children's bedroom has an outlet that is not mounted correctly and can be pushed into the wall. The outlet in the living room had no power at all. An outlet in the kitchen by the coffee maker has an open ground. An electrician should be consulted to correct all of these issues.

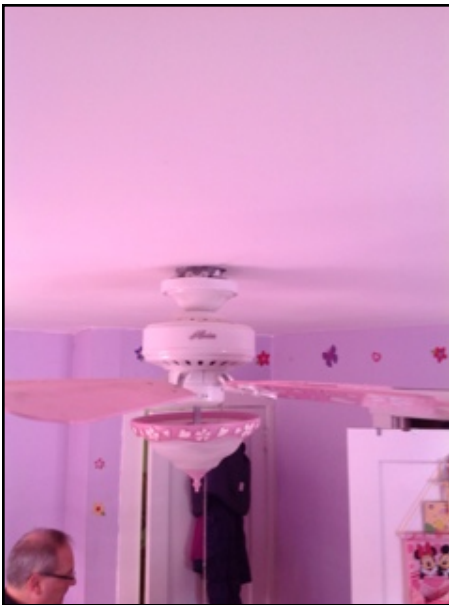
Figure 24-1

The ceiling fan in the children's bedroom is not functional. An electrician should be consulted.

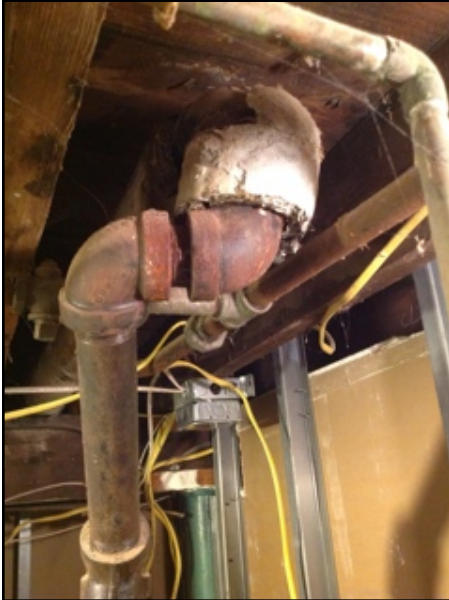
Figure 26-1

A steam pipe above the boiler has an insulator that MAY be asbestos. It should be sampled and tested by a licensed asbestos technician.

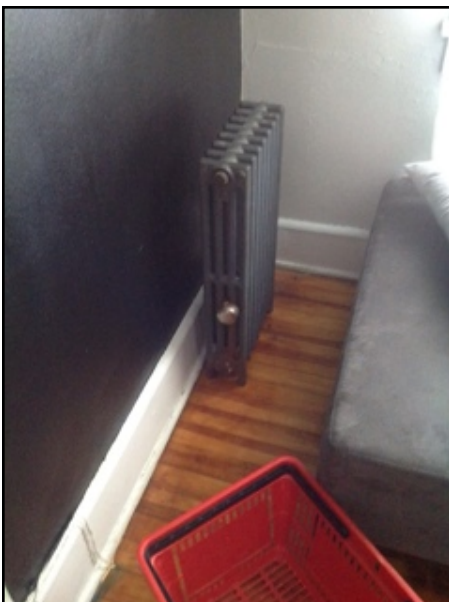
Figure 27-1

The radiator in the small upstairs front bedroom is not functional. A plumbing and heating contractor should be consulted.

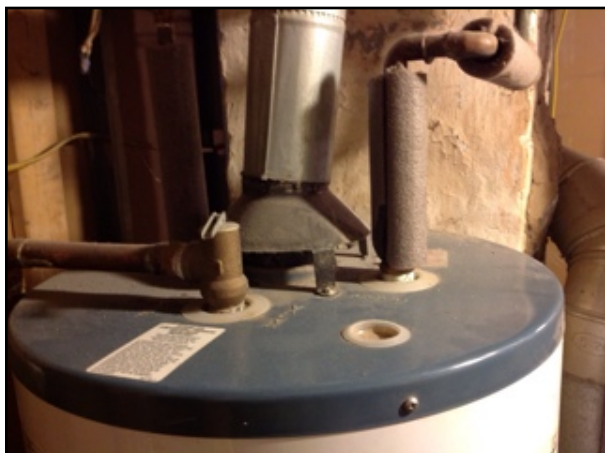
Figure 31-1

The vent stack for the water heater is not secure. A plumber should be consulted.

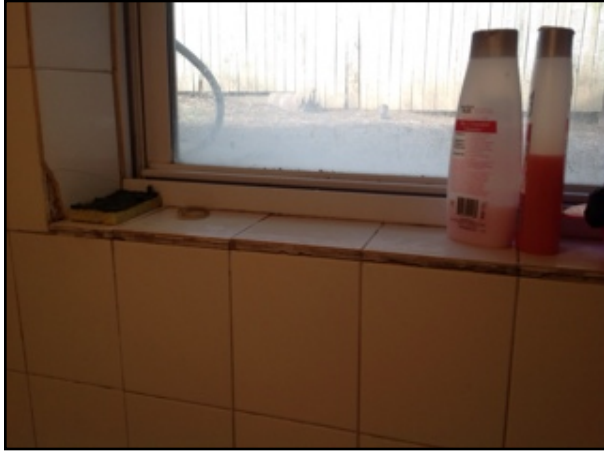
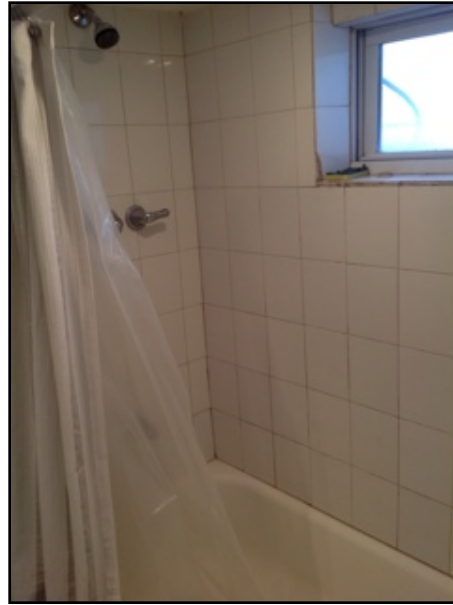
There are some broken tiles and missing grout in the shower in the basement bathroom. Water entry into the walls can lead to wood rot and mold.

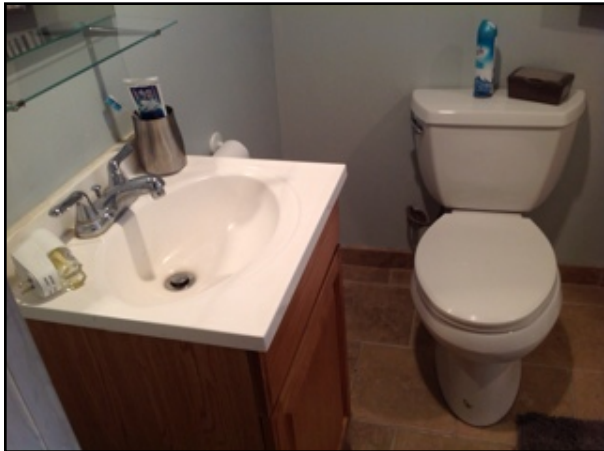
Figure 33-1

The toilet mounting in the basement bathroom is loose. This can lead to waste water leakage at the toilet flange.

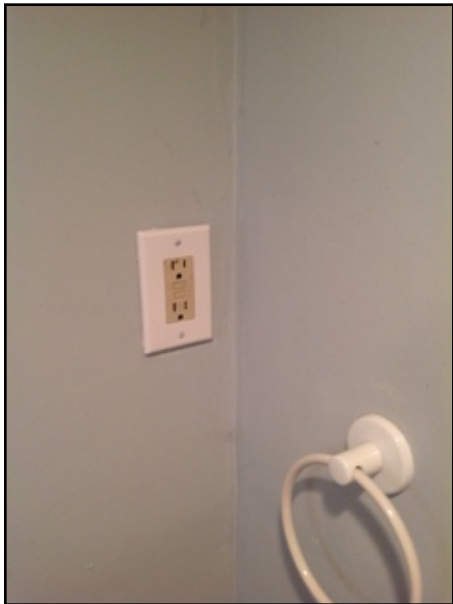
Figure 34-1

The GFCI in the basement bathroom has an open ground. This is unsafe and should be corrected by an electrician.

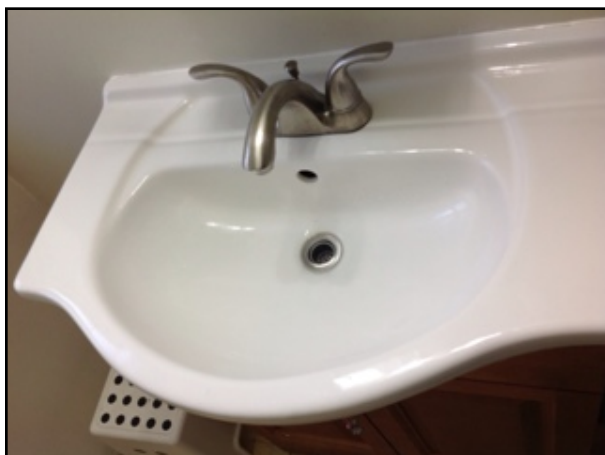
Figure 36-1

The stopper in the upstairs sink is not functional. Consult a plumber or handyman.

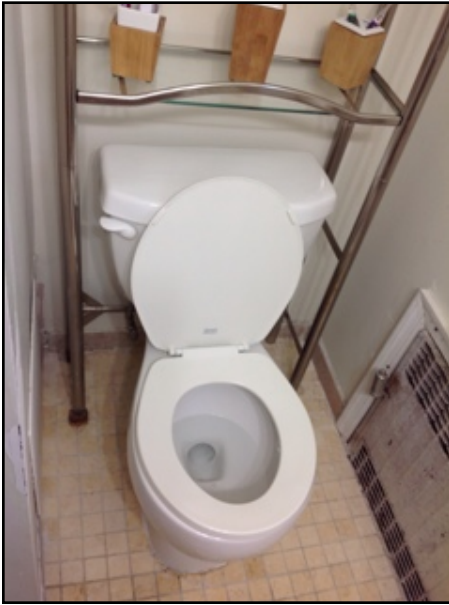
Figure 37-1

When flushed, the upstairs bathroom toilet will only swirl and not actually flush. A plumber should be consulted.

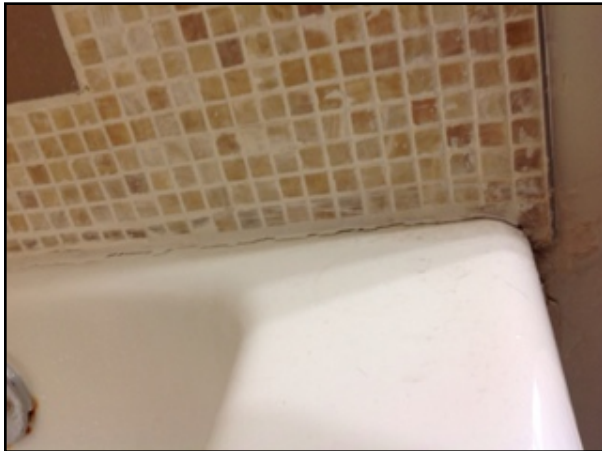
Figure 38-1

The grout around the shower is cracked in several spots. This can lead to water damage and mold.

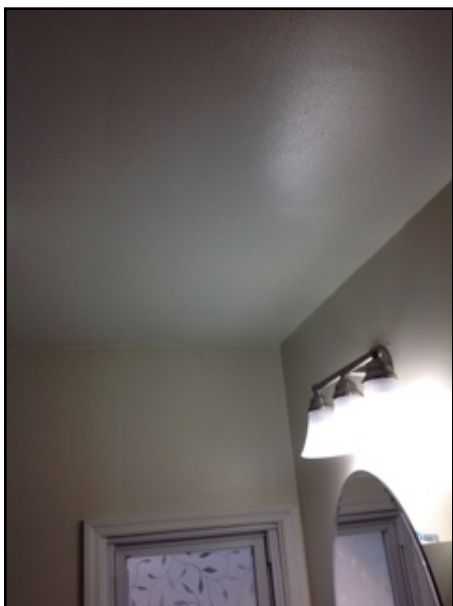
Figure 39-1

A ventilation fan is highly recommended in the upstairs bathroom.

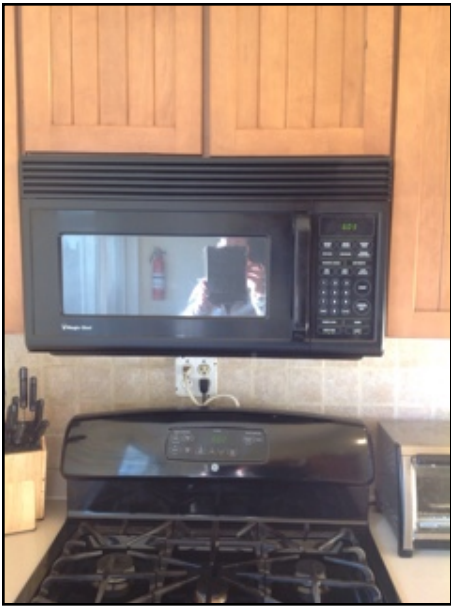
Figure 40-1

Comment 40:
The microwave appears to be weak. It would not light up a microchek, but it did warm a cookie.

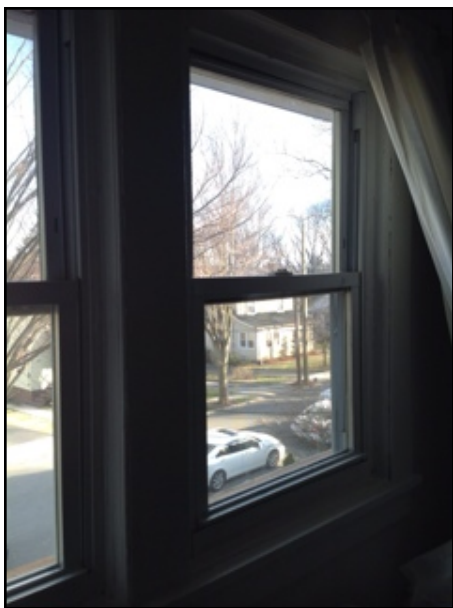
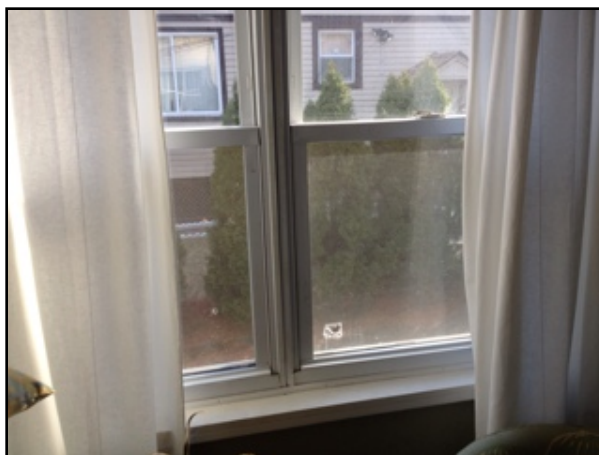
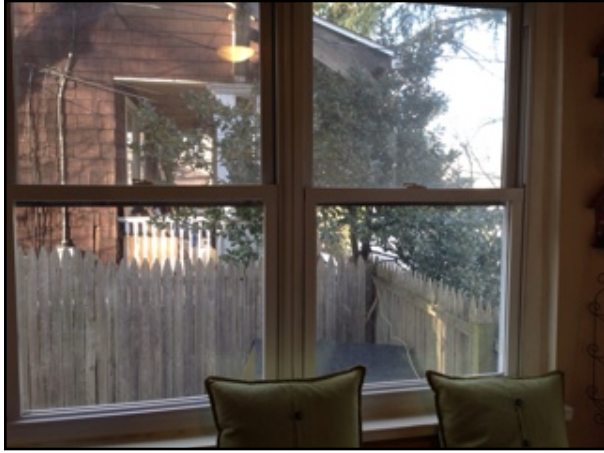
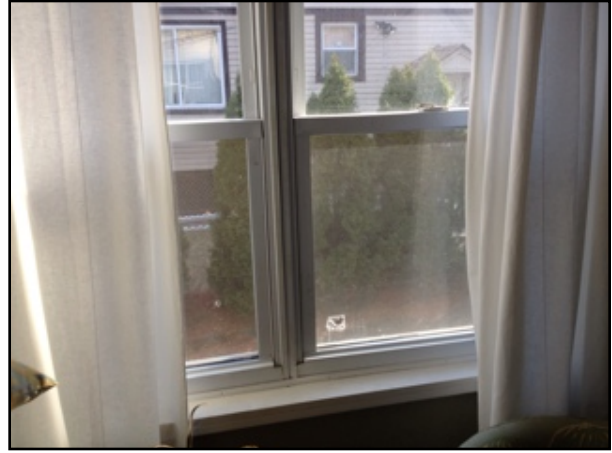
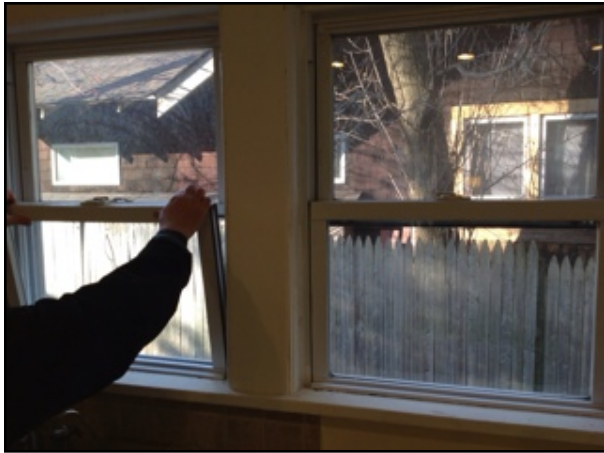
Many of the vinyl windows have broken open/close locks and tilt sash locks. A couple others were very hard to open and close.
